**Street & Drainage Advisory Taskforce
October 2023
Presentation**

Agenda: Streets & Drainage Advisory Task Force

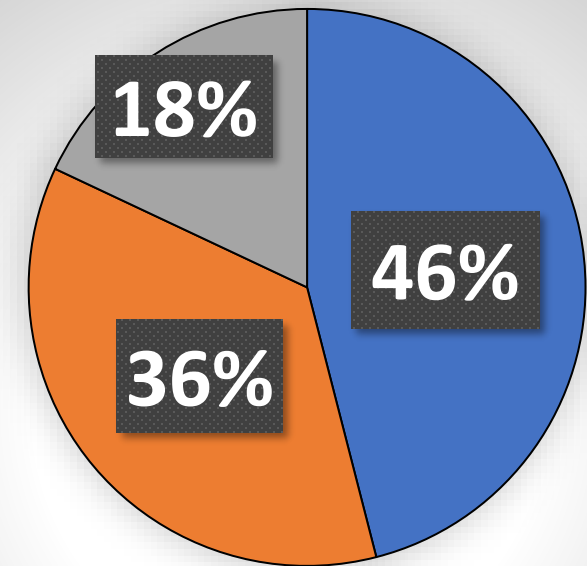
Total Runoff

- Runoff from natural surfaces: 46%
15.2 million gallons (of which 8.5 million gallons became runoff)
- Runoff from homes/buildings: 36%
12.0 million gallons (all of which became runoff)
- Runoff from road surfaces: 18%
5.9 million gallons (all of which became runoff)

- Natural Surfaces
- Homes/Buildings
- Road Surfaces

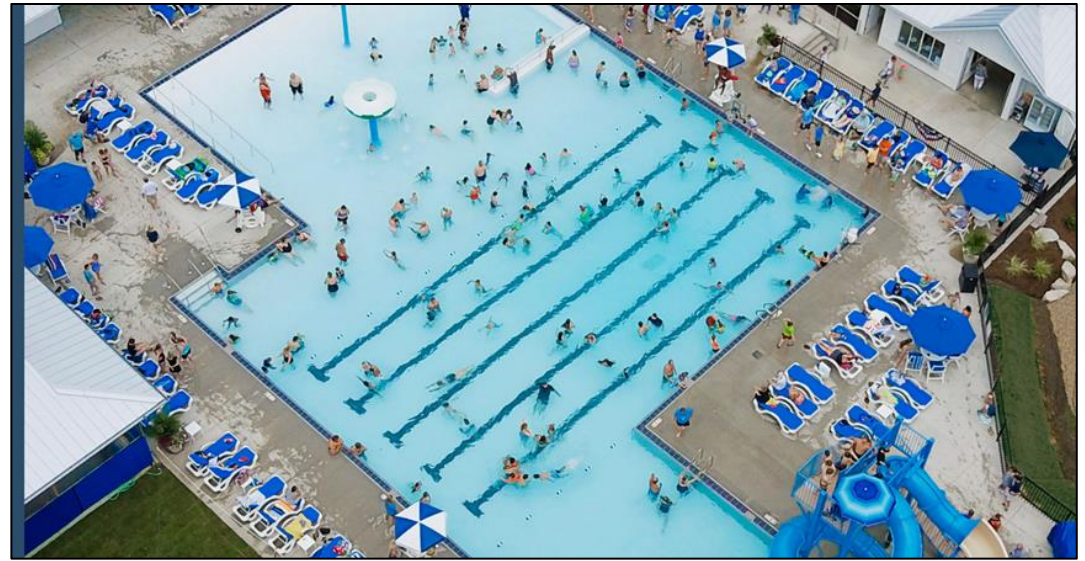
The pool holds 141,125 gallons. This volume of water is 233 times larger.

- The Lakeside built environment, buildings and roads, produces 68% of the runoff volume from any storm event or approximately **26.4 million gallons** for this storm.
